International Journal of Multidisciplinary Approach Research and Science

Volume 2 Issue 01, January 2024, Pp. 33-49 DOI: https://doi.org/10.59653/ijmars.v2i01.304

Analyzing Traffic Accidents on Pekanbaru-Dumai Toll Road from Road infrastructure Perspective

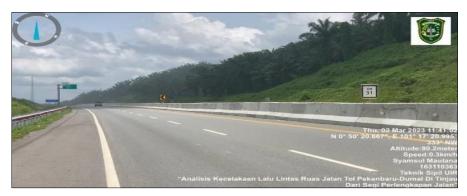
Figure 2. Condition of Section KM 31 A of the Pekanbaru-Dumai Toll Road

Section KM 31 of the Pekanbaru-Dumai toll road features an elevated bend stretching approximately 120 meters in length. It includes a lane width of 3.6 meters, an outer shoulder width of 3 meters, an inner shoulder width of 1.5 meters, and a median width of 3.8 meters, with a height of 1,000 meters. The road design complies with specified requirements and utilizes flexible pavement, as illustrated in Figure 2 and Figure 3 below.

Upon conducting a direct field assessment at the KM 31 location, our observations revealed a bend spanning approximately 120 meters. Road equipment facilities were identified, including directional signs indicating a leftward bend for lane A and a rightward bend for lane B, as depicted in Figures 2 and 3. Additionally, speed limit warning signs, guardrails, kilometer markers, road markings, and well-maintained road medians were present and still in good condition. However, one significant omission was the absence of road lighting in Section KM 31. According to Regulation No. 16/PRT/M/2014 issued by Indonesia's Minister of Public Works, which outlines the Minimum Service Standards for Toll Roads, road lighting is a mandatory facility to be provided by toll road operators. This regulation stipulates the requirement for road lighting installations on all segments of the Pekanbaru-Dumai toll road. Another noteworthy observation was the absence of noise tape before the bend. Following Indonesia's Minister of Transportation Regulation No. 82/2018, as outlined in Article 33, noise tape serves as an additional road feature designed to reduce vehicle speed, alert drivers to objects ahead that require caution, and signal accident-prone areas. From the analysis, it is evident that the equipment condition on the Pekanbaru-Dumai toll road, specifically on Section KM 31, presents several issues—namely, the absence of noise tape and public road lighting. These omissions can potentially lead to accidents, primarily due to the geometric characteristics of the curved road.

Based on data obtained from the Riau Regional Police Traffic Directorate (Indonesian: *Directorat Lalu Lintas POLDA Riau*), regarding Section KM 31 over three years (2020-2022), there were two cases of traffic accidents. These accidents were caused by the following factors.

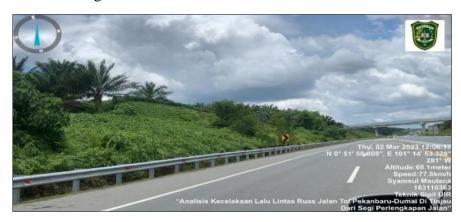
Figure 6. Condition of Section KM 36 A of the Pekanbaru-Dumai Toll Road

Section 36 of the Pekanbaru-Dumai toll road presents an elevated bend spanning approximately 150 meters. It has a lane width of 3.6 meters, an outer shoulder width of 3 meters, an inner shoulder width of 1.5 meters, and a median width of 3.8 meters, including the inner shoulders. The road surface meets the necessary standards and employs a flexible pavement, as shown in Figure 6 below.

Upon conducting field observations at the KM 36 location, researchers identified a bend with a length of approximately 150 meters. Road infrastructure features included a sign indicating a right bend from lane A, as well as a sign directing a left bend from lane B, as shown in Figure 6. Additionally, there were warning signs for speed limits, guardrails, kilometer markers, road markings, and road medians. All these facilities were in good condition. However, it is noteworthy that road lighting has not been installed on Section KM 36, even though Regulation No. 16/PRT/M/2014 issued by Indonesia's Minister of Public Works, outlining Minimum Service Standards for Toll Roads, mandates the provision of road lighting facilities, in this case on all sections of the Pekanbaru-Dumai toll road. Furthermore, it is essential to mention that there was a lack of noise tape before the bend. According to Indonesia's Minister of Transportation Regulation No. 82/2018, as outlined in Article 33, noise tape is additional road equipment designed to reduce vehicle speed, alert drivers to objects ahead that require attention, and signal accident-prone areas. Based on the observations, the equipment on the Pekanbaru-Dumai toll road, specifically at Section KM 36 has two issues, as it lacks noise tape and public road lighting. These shortcomings can contribute to potential accidents due to the geometry of the curved road.

Based on data obtained from the Riau Regional Police Traffic Directorate regarding Section KM 36 over three years (2020-2022), there were four cases of traffic accidents. These accidents were attributed to the following factors.

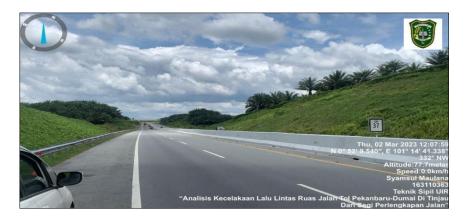
Figure 7. Condition of Section KM 37 A of the Pekanbaru-Dumai Toll Road

Section KM 37 of the Pekanbaru-Dumai toll road features an uphill and downhill flyover spanning approximately 150 meters in length. This section has a lane width of 3.6 meters, an outer shoulder width of 3 meters, an inner shoulder width of 1.5 meters, and a median width of 3.8 meters. It meets all required specifications and utilizes a flexible type of pavement, as shown in Figure 7.

Based on direct field observations at the KM 37 location, this section features an elevated and descending curve, as shown in Figure 7, spanning approximately 150 meters. Road equipment facilities include signs directing a right bend from lane A and a sign directing a left bend from lane B. The section is also equipped with speed limit warning signs, incline and descent warning signs, guardrails, kilometer markers, road markings, and road medians, all of which are in good condition. However, it is important to note that road lighting on Section KM 37 has not been installed. According to Indonesia's Minister of Public Works Regulation No. 16/PRT/M/2014, which outlines Minimum Service Standards for Toll Roads, toll road providers—including those responsible for the Pekanbaru-Dumai toll road—are required to provide road lighting facilities. In addition, there is no noise tape before the curve. The guidelines set by Indonesia's Minister of Transportation Regulation No. 82/2018, Article 33, mention that noise tape serves as additional equipment on the road to reduce vehicle speed,

alert drivers to objects ahead that require caution, and remind them of accident-prone areas. In summary, the equipment on Section KM 37 of the Pekanbaru-Dumai toll road has certain deficiencies, specifically the absence of noise tape and road lighting, which could potentially lead to accidents due to the geometric conditions of the curved road.

- 1. Installation of Noise Tape: Place noise tapes before corners to signal accident-prone areas, encouraging drivers to reduce their vehicle speed.
- 2. Road Lighting: Implement road lighting on sections without it to improve nighttime visibility for toll road users.
- 3. Warning Signs: Add new warning signs in accident-prone areas.
- 4. Vehicle Quarantine: Establish regulations requiring road users to quarantine their vehicles and drivers at a designated toll gate before continuing their journey to minimize accidents caused by vehicles and drivers.
